EPA
LIBERIA

Field Report of an Alleged Water Pollution from BMMC's Operation in NLGM, Grand Cape Mount County

Presented by
The Investigation Team
February 20, 2023

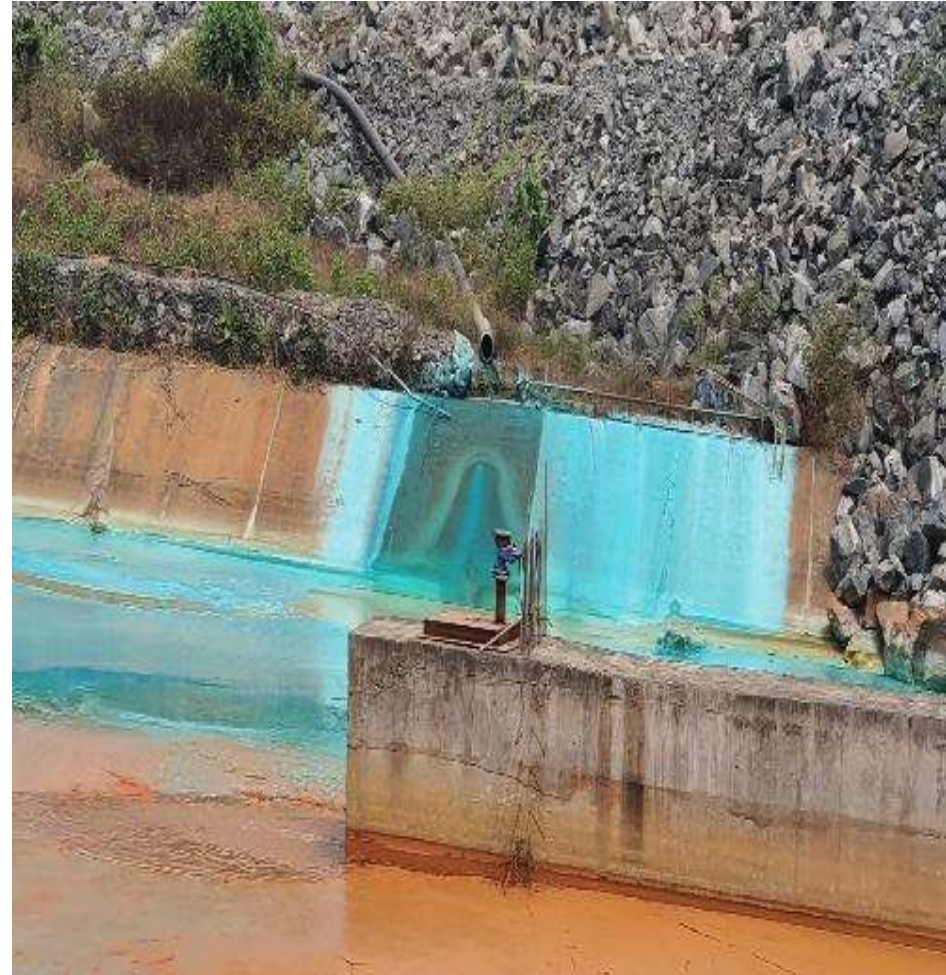
- The team observed that BMMC discharged/released a huge quantity of copper sulfate into the TSF-R. The copper sulfate solution was seen entering into the receiving environment.
- The Gabion Basket installed at the TSF-R and beyond are partially damaged
- Fingerlings were observed in the water at JAKSW-2, however, the team observed evidence of dead fish near the water at JAKSW-2 (in Jekandor)

- The results of the analysis showed that free cyanide and copper levels were higher than acceptable at six of the nine sampling points. Copper and free cyanide levels recorded in the study are directly emanating from BMMC tailing Storage Facility at New Liberty. The release of copper sulfate directly into the TSF-R is a violation of **Section 5.2e** of the **BMMC TSF-III Permit** which requires the company to seek approval from the Agency if there is a need for chemical treatment of tailings within the facility.

- No such approval was given by the Agency, therefore the company was in violation. The unapproved release of copper sulfate into the TSF-R and the nearby receiving water body resulted into water pollution which is a violation of **Part V: Section 61 of the EPML** which strictly prohibits the pollution of water in any form and manner. This is also clearly articulated in **Section 10** of the **BMMC's (NLGM) Effluent Discharge Permit**

A huge quantity of raw copper sulfate observed at TSF-R

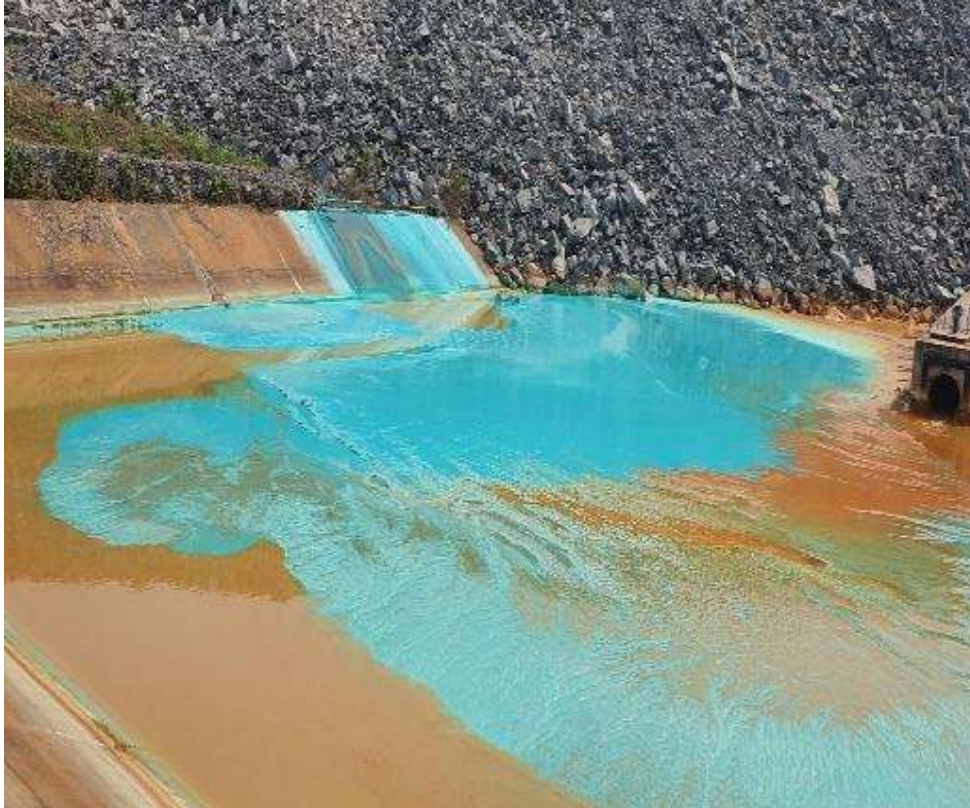
A huge quantity of raw copper sulfate observed at TSF-R

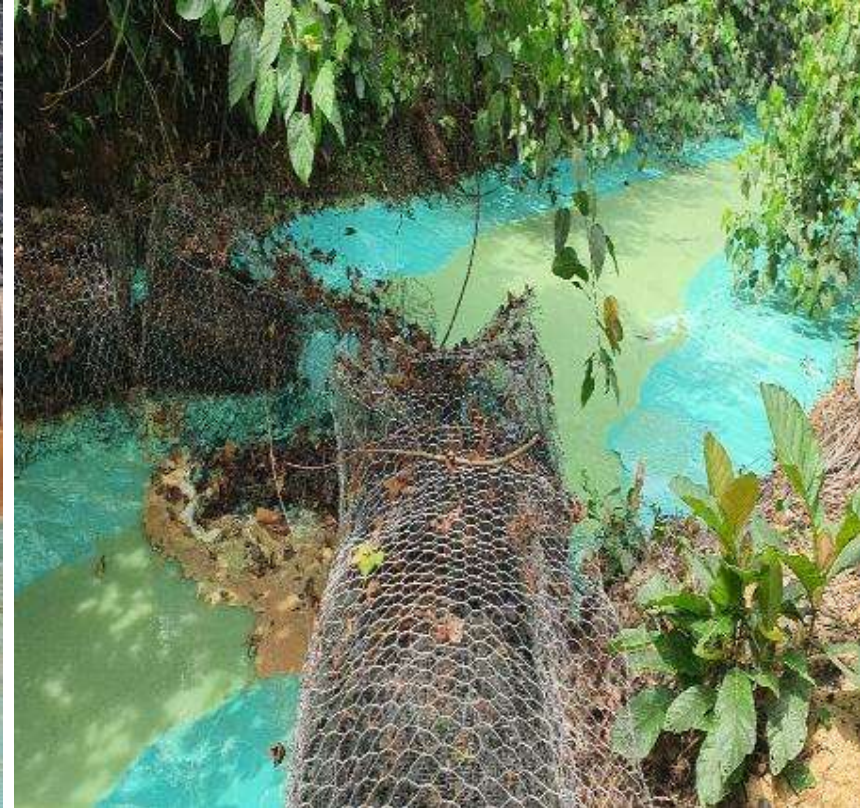
Flow of raw copper sulfate observed beyond Gabion basket at TSF-C.

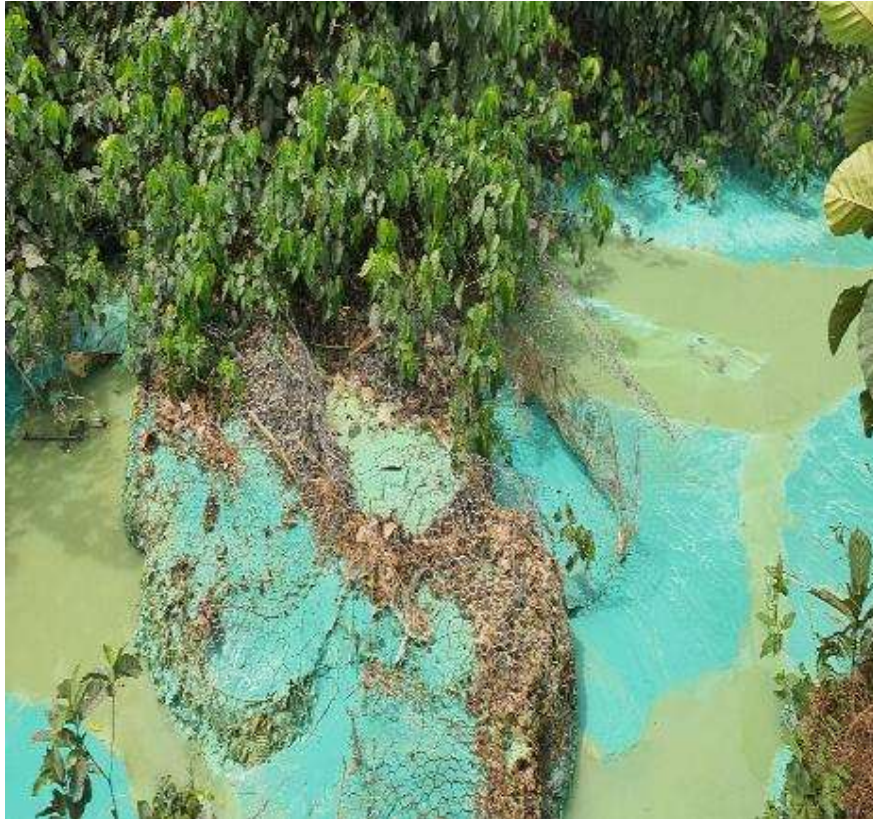
Damaged Gabion Basket observed at the TSF-R

- Invite BMMC to “show cause why’ they should not be held liable for the violation stated in the report.
- Prepare and issue BMMC a non-compliance notice for the violation and communicate associated penalties.
- BMMC should regularly repair and upgrade gibbon baskets as provided in Section 6.3 and 6.4 of the **BMMC’s (New Liberty) Effluent Discharge Permit.**

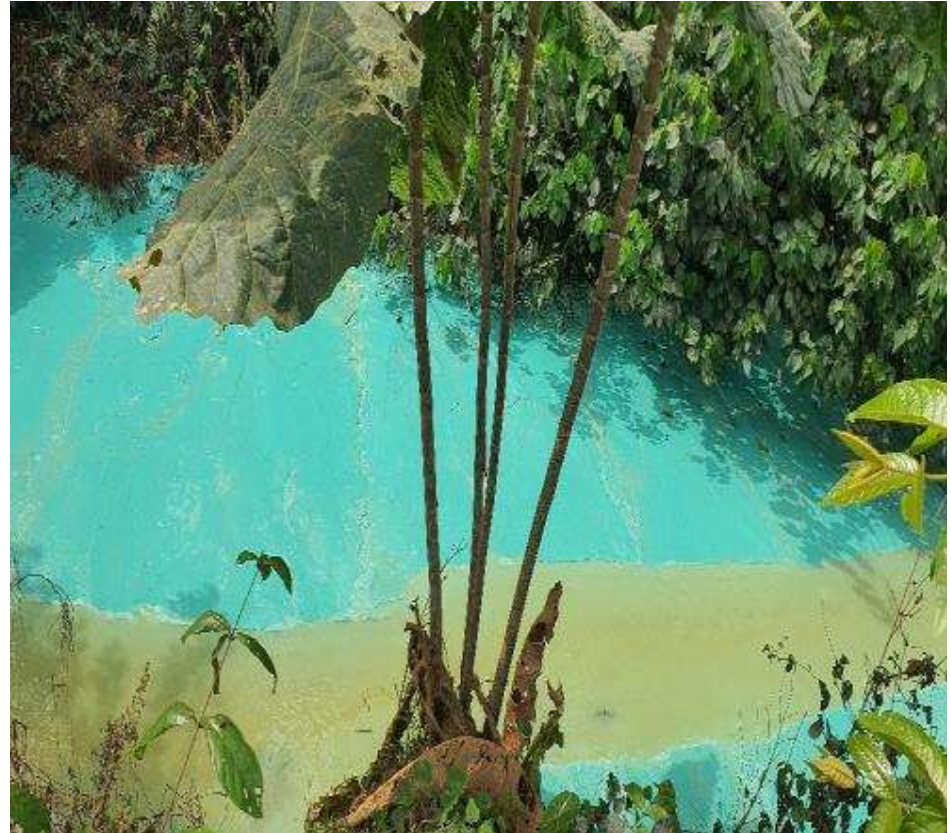
Flow of raw copper sulfate observed entering the environment

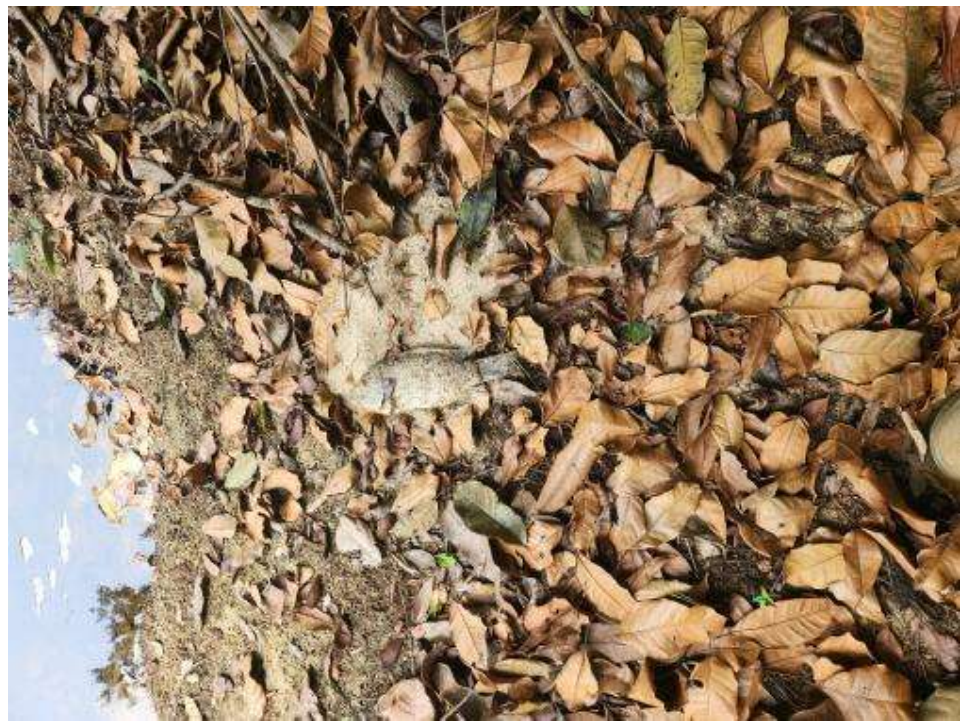
- The team observed evidence of dead, decomposed fish species tilapia, downstream of Marvoe creek;
- The death of aquatic species may have resulted from elevated free cyanide and dissolved copper levels due to exposure to higher than permissible limits of free cyanide from BMMC's TSF;

Dead fish observed at Marvov creek (downstream)

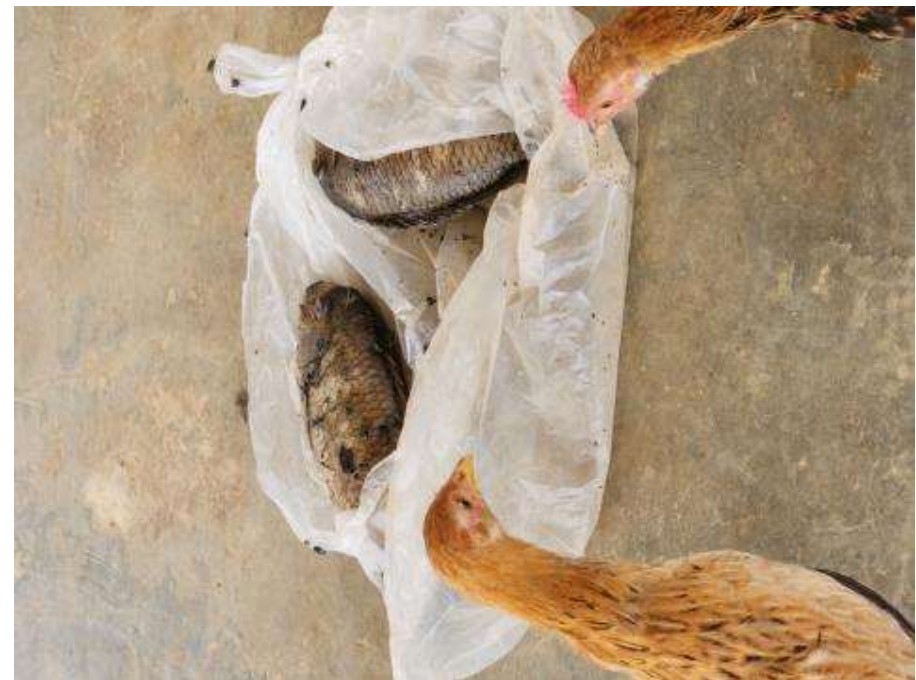
- The team confirmed the death of two tilapia species downstream of the Marvoe Creek;
- Two additional tilapia species were also seen in the village of Jekandor;
- Bea Mountain had supplied water and food items two weeks prior to the discovery of dead fish along the river banks;
- The Community informed the EPA that their lawyer collected a sample of the dead fish and brought it to Monrovia for laboratory analysis to determine the cause of death;
- Fingerlings were observed at the downstream portion of the river where the dead fish was discovered;
- The community vowed to protest if the issue of the pollution is not be adequately address by the Government;
- The people of Jekandor continue to requested to be relocated; they even claimed to have found a land;
- Some residents of Jekandor have left the village for fear of the first incident, thus reducing the initial population (n=250);

Dead fish observed in the village of Jekando
