EPA
LIBERIA

**FIELD ASSESSMENT
AT BEA MOUNTAIN
MINING
CORPORATION IN
KINJOR, GRAND
CAPE MOUNT
COUNTY**

**Presented by
EPA Technical Team**

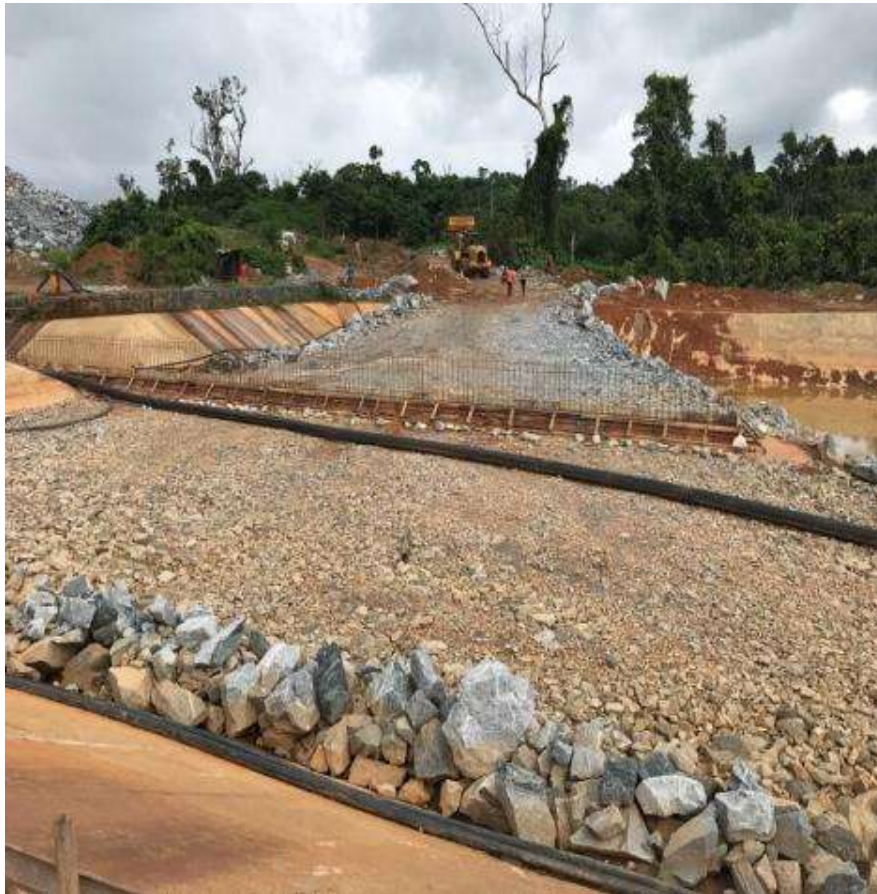
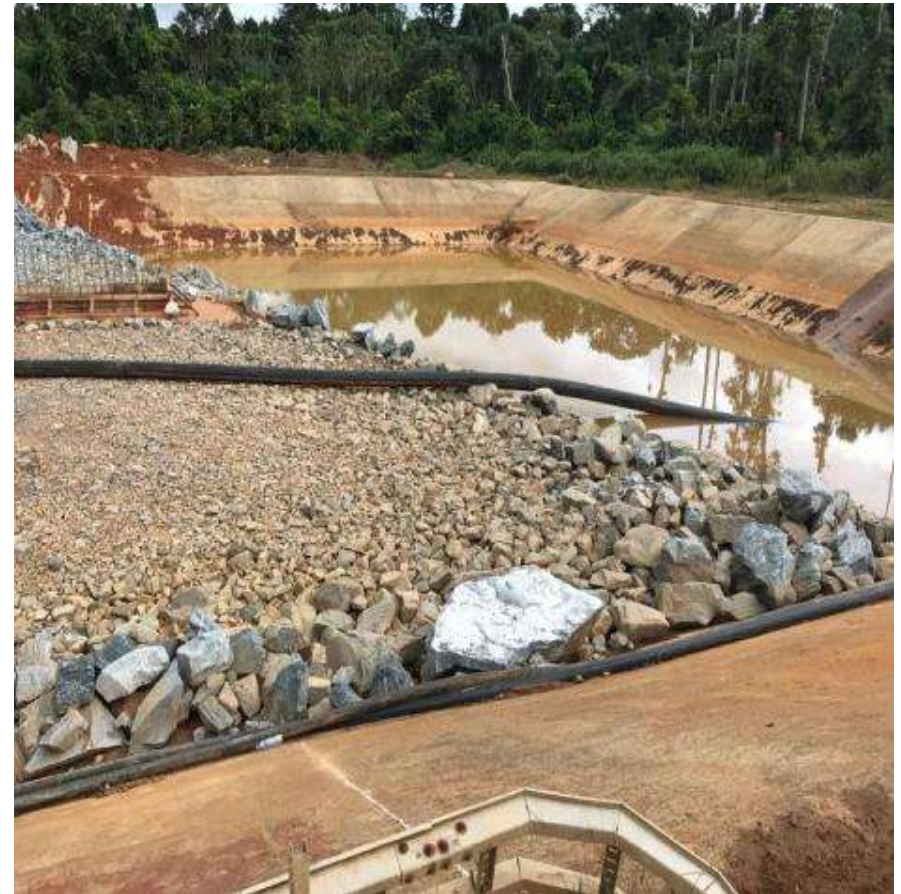
The company is carrying on construction of a canal in the TSF R without approval from the Agency

- Bea Mountain is operating an open wastewater treatment system at TSF R contrary to the closed system approved by the agency with out notifying the EPA.
- The company is also carrying on construction of a canal in the TSF R without approval from the Agency.
- The Company refused to grant the assessment team access for physical inspection of its laboratory and reports from previous analysis.
- Effluents from the Penstock system pumped into the environment (through a metal pipe) contains elevated (above permissible limits) levels of dissolved copper and iron
- Phase III amendment to the TSF has not been permitted by the Agency, yet upgrade began since December, 2019

- The senior management including the relevant technical staff of Bea Mountain should be invited for a conference for presentation of key findings from the assessment.
- The various non-compliance issues revealed by the team should be preceded by the imposition of by fine.
- Bea Mountain should prepare a sedimentation pond few meters from the discharge point at TSF R. This action will allow the suspended particles settle in the pond and the supernatant effluent eventually flows in the environment.
- The entire tailing dam should be surrounded by embankment or retaining wall. This will not allow the continuous extension of the tailing dam
- Bea Mountain should be given one week to submit a wastewater testing report from a third-party accredited laboratory.

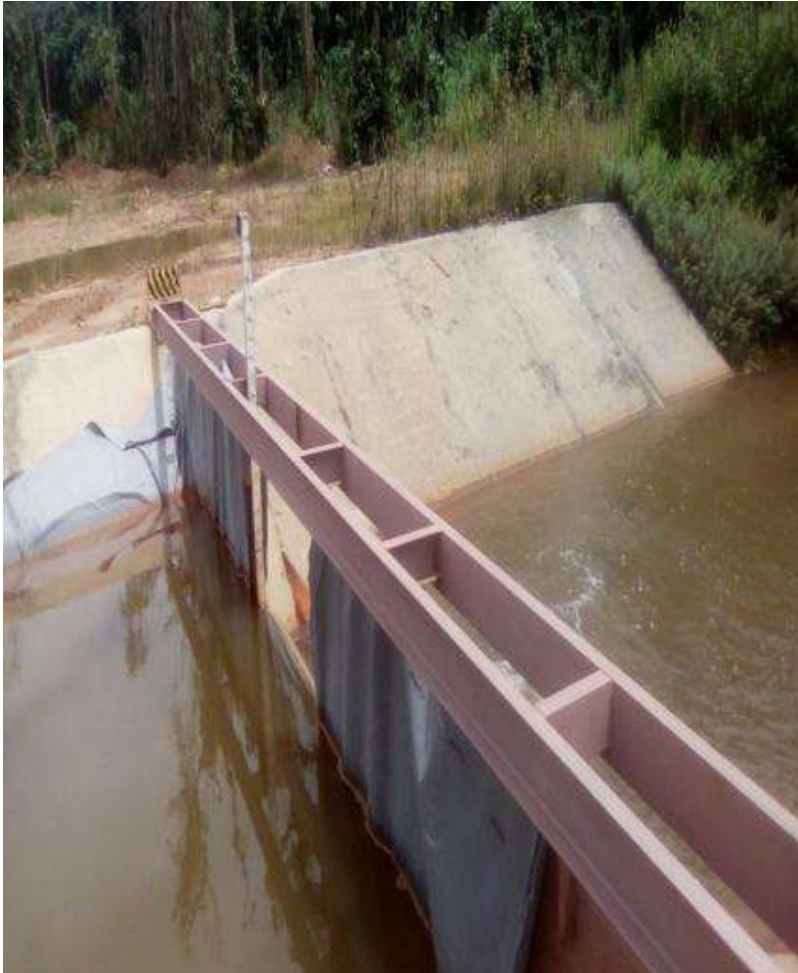
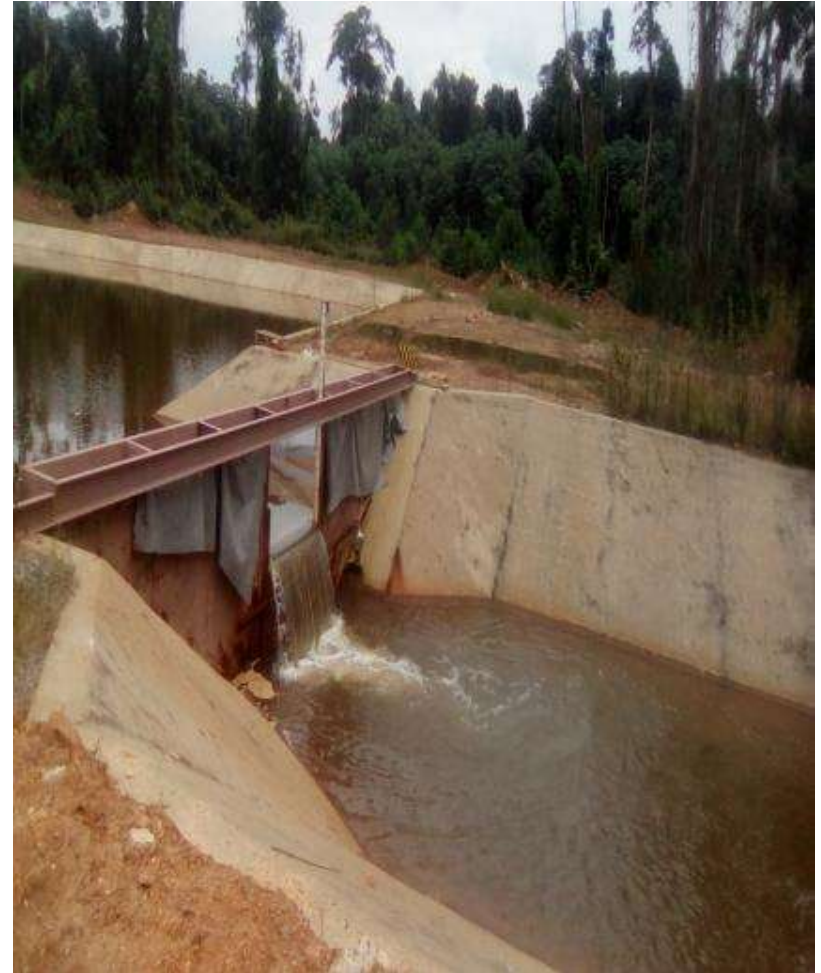
TSF-R Prior to new intervention

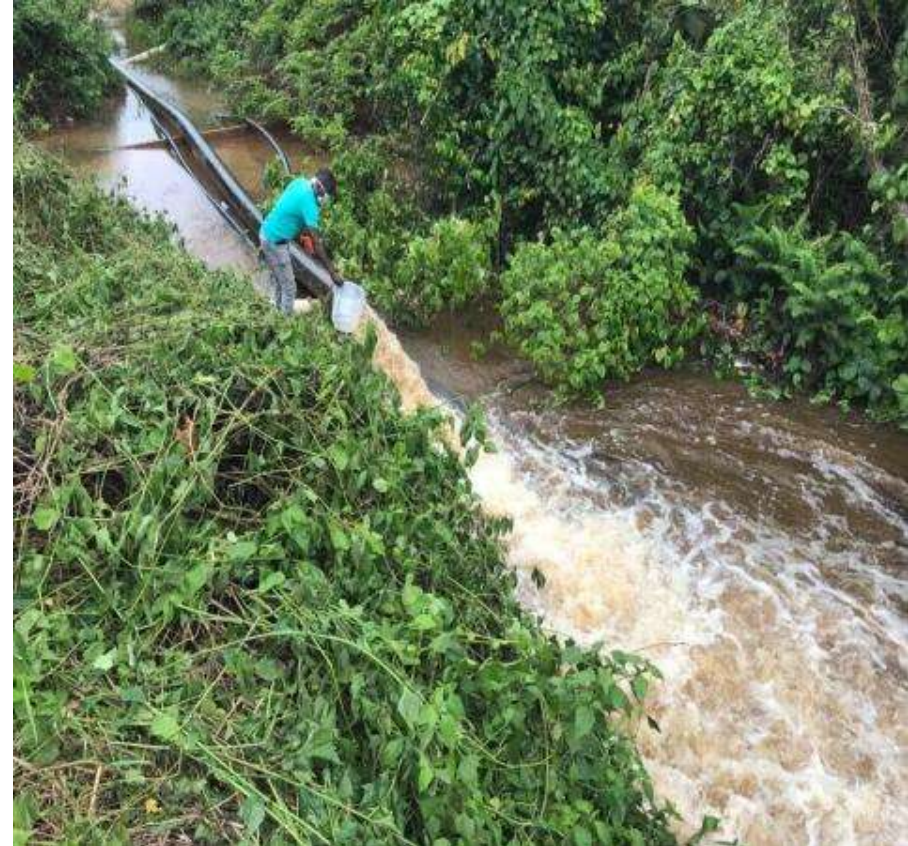
- ❖ The TSF-R which was used as one compliance monitoring points has been closed since December 2019
- ❖ A metal pipe about 25cm in diameter is being used to drain water from penstock system and discharge the water into the wetland just beyond the return water dam (TSF-R).

- EPA should commence a monthly compliance-monitoring visit to all mining companies.
- BMMC should design and implement (pending EPA approval) remedial measures for current dissolved iron and copper contamination of the environment emanating from discharge from the penstock system (Penstock VI)
- BMMC should immediately hire a third party EPA accredited laboratory to commence regular quality control monitoring of effluents

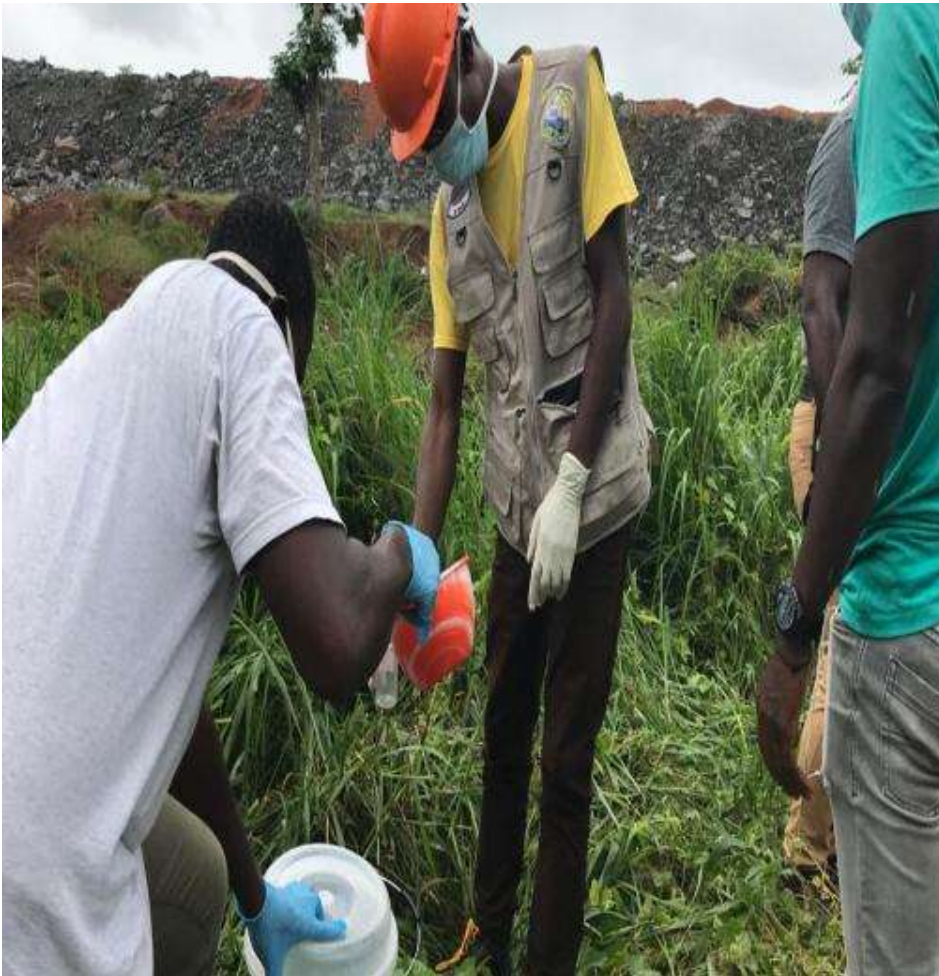
Sampling of Effluents (Left) and Analytical Methods Used (Right)
